ALPINA DAM

(Inventory Number 778)

St. Lawrence River Basin
LEWIS COUNTY,
NEW YORK.

PHASE I INSPECTION REPORT,
NATIONAL DAM SAFETY PROGRAM

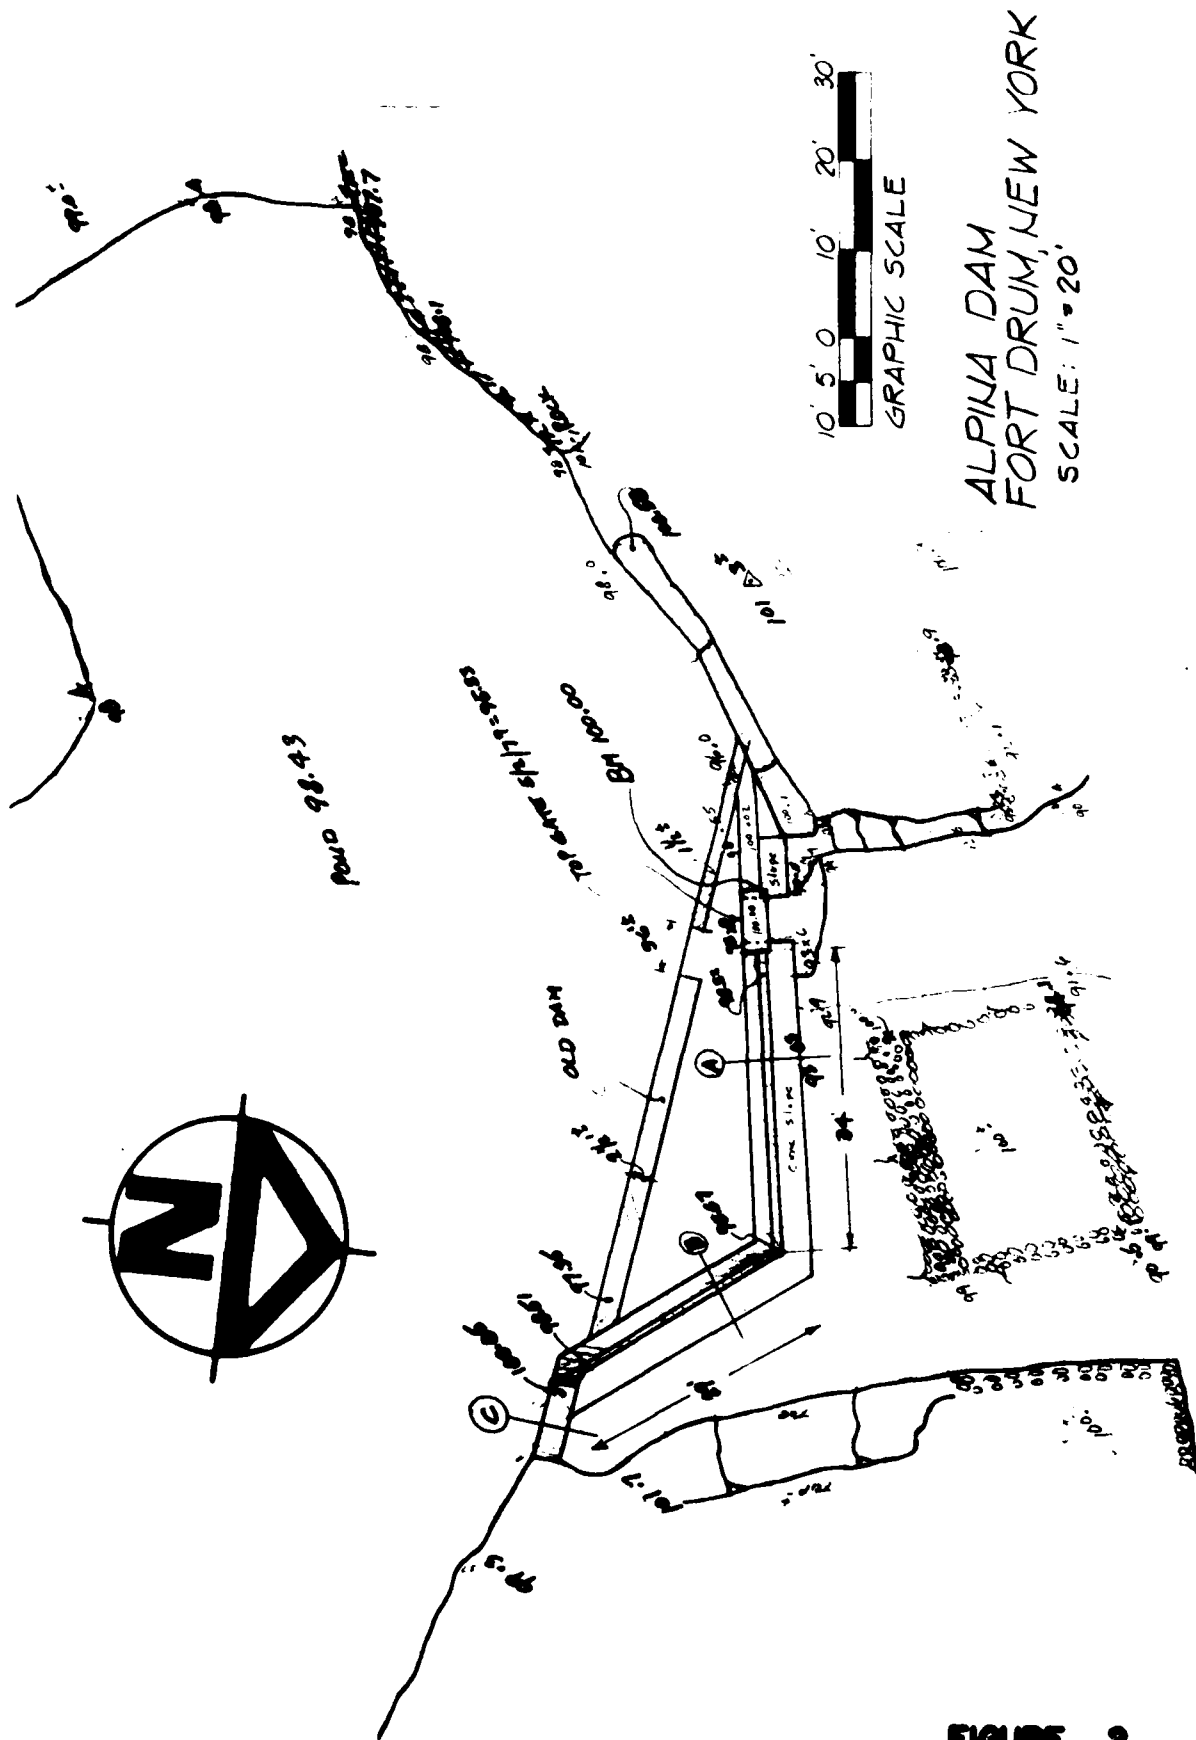
FIGURE 2

The dam and spillway system are shown in the Sketches prepared by Dale Engineering Company in Figures 2 and 3. The dam was reconstructed in 1933. The east abutment is along the alignment of the original dam. This abutment is founded on bedrock and there is no indication of seepage along the abutment or along the spillway of the dam. Near the west abutment of the dam, a small walkway crosses the control spillway. The concrete supporting this walkway is cracked near the elevation of the top of the emergency spillway. The west abutment of the dam is also founded on bedrock and meets the alignment of the old dam at the west abutment. On the west abutment, a wing wall which extends beyond the dam structure is deteriorated on the upstream side and severely undermined. The dam is in generally good structural condition except for this wing wall on the west abutment. There is no evidence of cracking nor is there evidence of seepage. There are provisions on the top of the emergency spillway for mounting flashboards, although there are no flashboards in the area of the dam.

No information relating to the design and construction of the dam structure has been made available. A field survey undertaken as part of this Phase I study has provided information on dam cross-sections (Figures 2 & 3) but did not extend to determining properties of the dam's concrete and foundation rock. Stability evaluations have been performed, utilizing the obtained cross-section information to obtain an indication of the dam's performance when subject to different possible loading conditions. In these analyses, assumptions were required in regard to concrete and rock properties, the geometry of the dam, and cross-section for the assumed critical location.

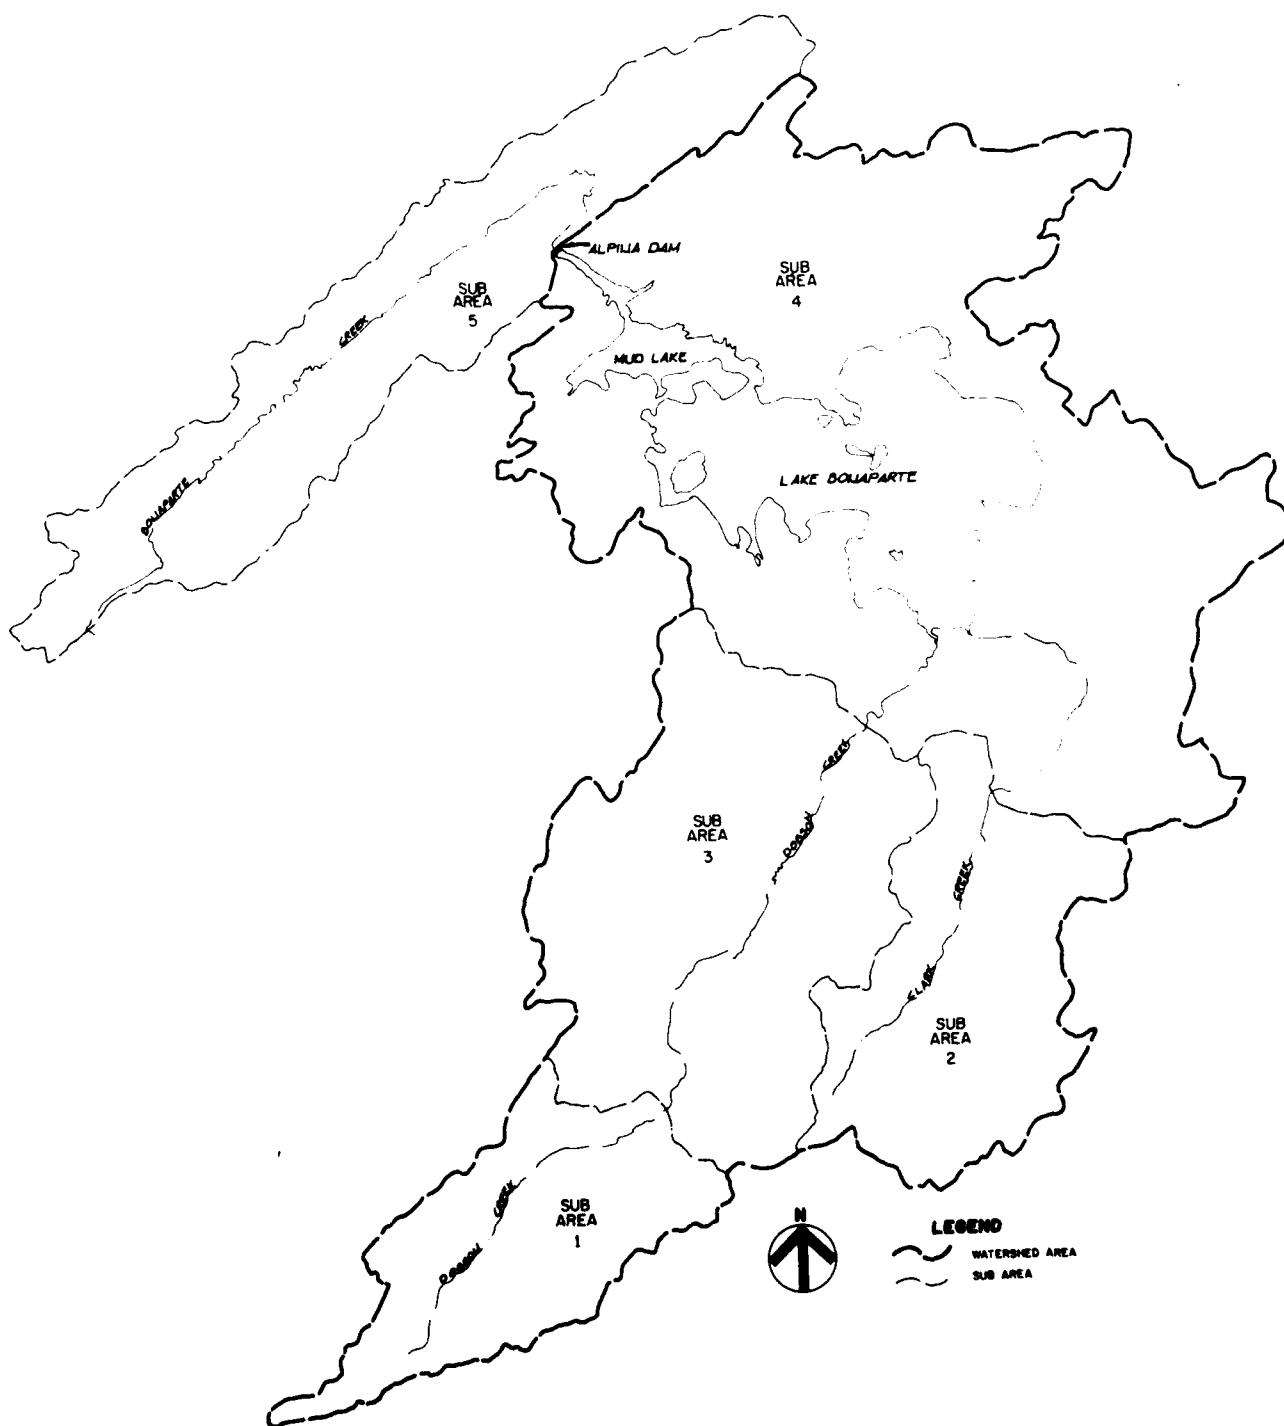
DRAINAGE BASIN PLAN

hydrograph was determined by applying the PMP to the unit hydrographs and runoff and routing to the dam sites (Figure 5). The PMF results in an inflow into the impoundment of 26,219 cfs. The 1/2 PMF inflow is 13,116. Due to the storage effect of the lake, the discharges were significantly reduced to 8,923 cfs for the Probable Maximum Flood and 2,377 for the 1/2 PMF.

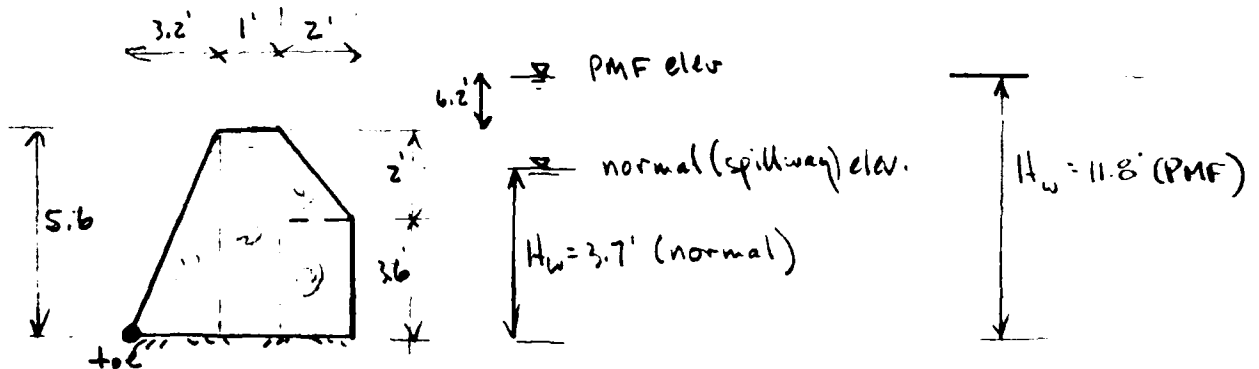
assumed x-section

low hazard class.
seismic zone 2
use ice force = $5K/ft$

note: neglect downward wt. of water acting on upstream slope face of dam

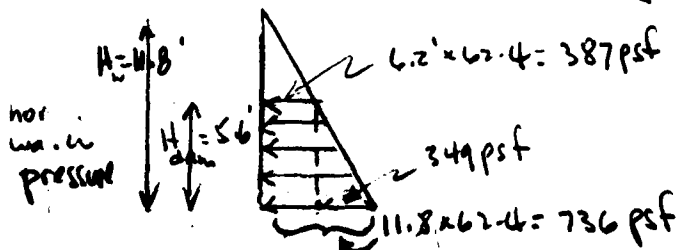
The analysis indicates unsatisfactory stability against overturning for certain combinations of loading conditions.

(ii) moments causing out: horiz. water press + uplift. water press.

$$= (1.387 \times 5.6 \times \frac{5.6}{2}) + (1.349 \times \frac{5.6}{2} \times \frac{5.6}{3}) +$$

$$+ (736 \times \frac{6.2}{2} \times \frac{2}{3} \times 6.2) = 6.07 + 1.82 + 9.4$$
